Sample Company

Outdoor Substation

2500kVA Transformer

Problem #	1
Repair Priority	Critical
Hot Spot	43.0°C
Ref. Temp	19.0°C
Delta T	24.0
Time	Any Time
Date	Any Day

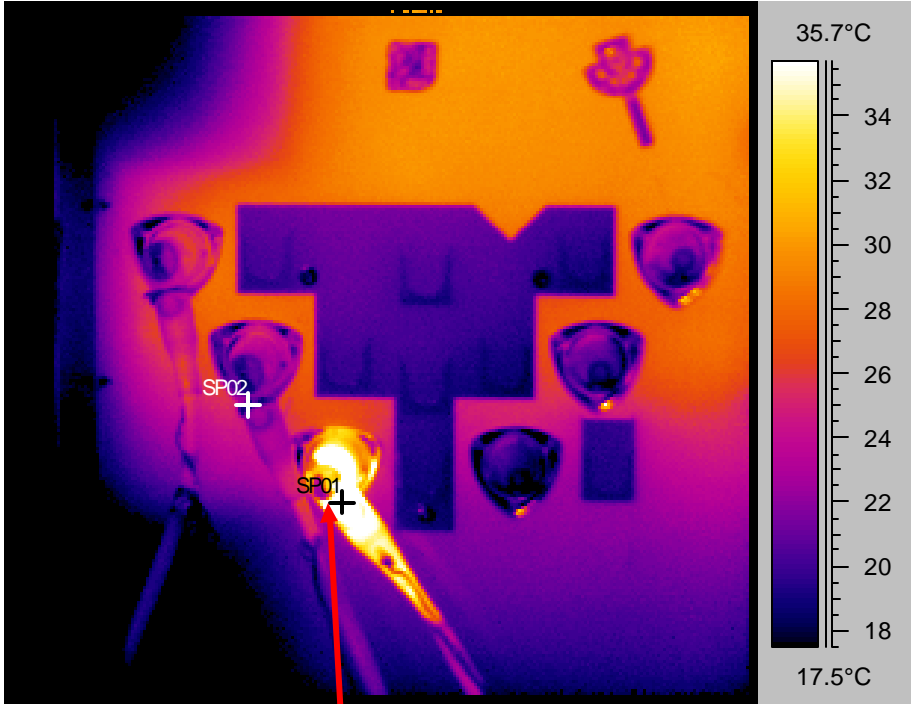
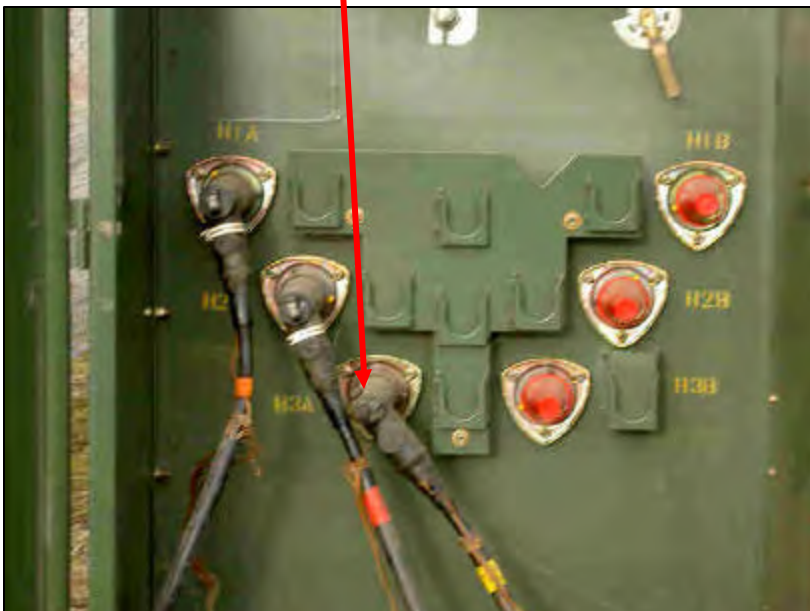
The connection is overheating by **24°C**. High Voltage elbow terminator may have a defective "cable-to-terminator" connection inside the elbow terminator.

Critical Repair Priority - Repair as soon as possible.

Replace the deficient High Voltage elbow terminator. Based on our experience, the best solution is to replace the elbow terminator.
